Manhole Inspection Summary

Manhole # S01EE2036MH

Insp Date: **8/8/06 12:00 AM**

Location Address: **3301 Bancroft Rd** Cross Street: **Western Run Dr**

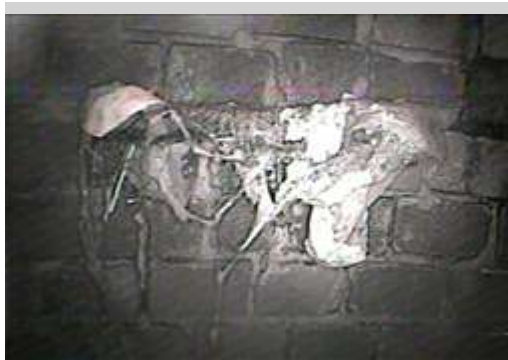
Evidence of Surcharge

Surcharge ☒ **Evidence Of Surcharge** Depth: **6** (ft.) ☐ Active Surcharge Present

debris on step

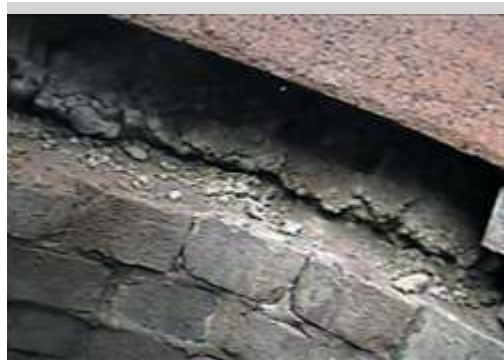
Defect

Adj. Missing brick

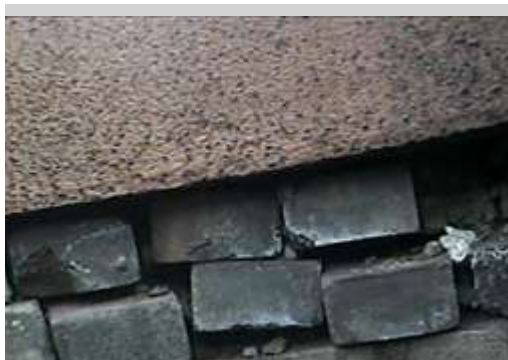
Defect

Chimney / Frame Adjustment ☒ Exists Material: **Brick** ☐ Parged Height: **6** (in.)
Condition: ☐ Sound ☐ Cracked ☐ Root Intrusion ☒ **Loose Brick** ☐ Deteriorated
Infiltration: ☐ None ☒ **Joint** ☐ Cracks ☒ **Mortar** ☐ Roots ☐ Wall

Adj. Loose Brick

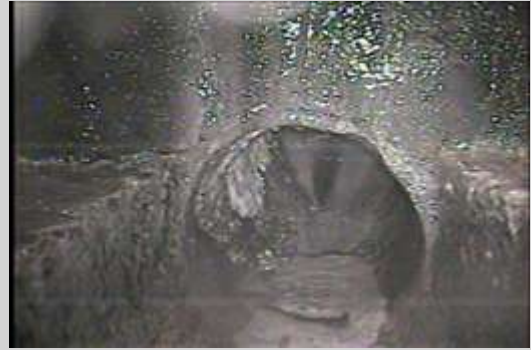
Drop In @ 6 O'Clock

Drop Condition: **Clogged**
